## **Massachusetts State Laboratory**

### **Improvements Study ST 02R**

#### **Inventory and Analysis**

Project Number DPH 0702 ST1

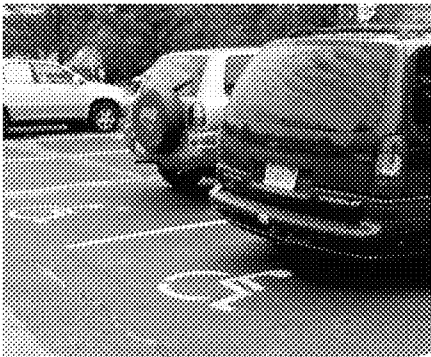
The ADA overview by KlingStubbins, dated September 25, 2009 noted that not all entrances are accessible, and further recommended that all entrances used by general public and general employees should be ADA compliant, and fitted with power assist openers for high-traffic doors.

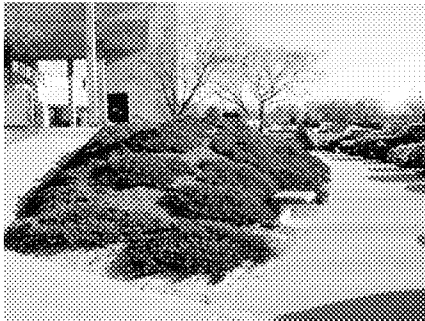
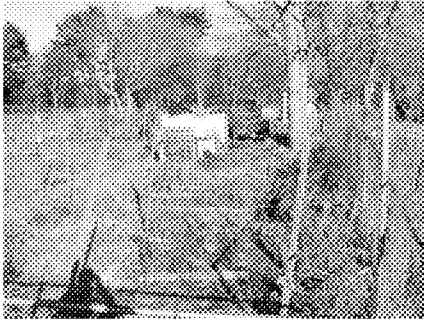
***Community Garden***

The Community Garden is located directly adjacent to the east parking lot. At times the garden appears to be somewhat messy and not well maintained. The chain link fence enclosing the garden is displaced and out of alignment in places. With some carefully chosen border planting and proper care and maintenance, the garden could be an aesthetic focal point for the property and a showcase for public and private collaboration.

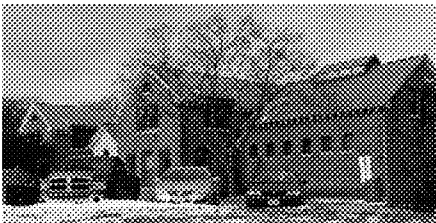
##### ***Stable Building***

- Skylight leakage is an ongoing problem.
- Aluminum window frames with insulating glass were installed in the early 1990's and are in satisfactory condition along with the window sealants.
- Coal hole below grade did have a leakage problem but is now capped off at the exterior grade with no evidence of water infiltration to date.
- Extensive water damage is observed to portions of the ceiling and walls at the skylights. Blistering and peeling paint, stained wall surfaces and a bucket positioned to collect water.
- There is some mortar deterioration of the brick walls, approximately 5% to 10% of the mortar joints for the entire building require repair.
- Peeling paint on the wood cornice trim.
- Broken roof slates at the roof edge and to some extent in the overall field of the roof area.

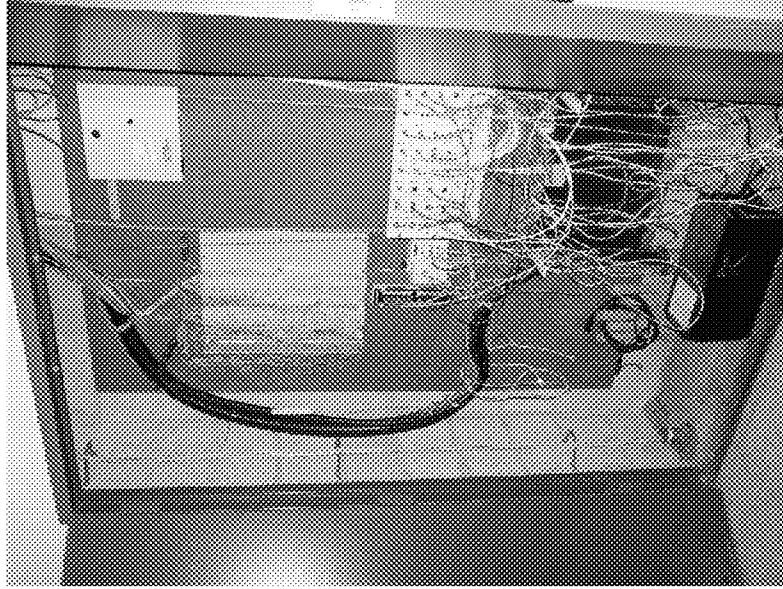
## Building Overview – What is Deficient?

- Aged Electrical, Plumbing & HVAC Distribution Systems – further upgrades required
- Aged laboratory infrastructure (e.g. acid waste)
- Replace 220 VAVs in remainder of Tower Building
- Aged I/T Infrastructure
- Aged Elevator Components
- Exterior Envelope Deficiencies
- Accessibility Deficiencies
- Tired Finishes
- Low floor to floor height
